Veda mladých 2018, Science of Youth 2018

PROCEEDINGS OF REVIEWED CONTRIBUTIONS

Surface stability of the slope

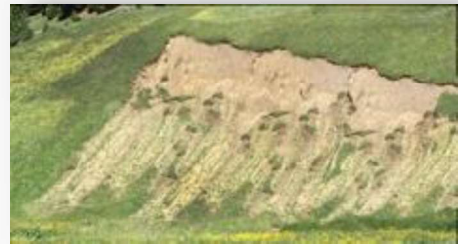
Figure 1: Significant disruption of slope surface stability

Measurements were carried out at the study locality in the cadastral area of Liptovský Mikuláš, where the erosion and slope processes were monitored from March 2010 until February 2012 due to landslide event creating pressure on the local road. Firstly, we estimated soil erosion risk using the Universal Soil Loss equation by Wischmeier, Smith (1978) $G = R.K.L.S.C.P$ and the annual mean soil loss was calculated in tonnes per hectare per year. Geodetic measurements have been performed for the purposes of determining planar and elevation information to subsequently determine the values of soil erosion factors. Also pedological properties and representative soil cover were evaluated. The territory threatened by landslides was located on Cambisol originating from the flysh. Medium heavy deep soils with a Soil Unit Code BPEJ 0869412 are represented on the area of 4.2 ha. The proportion of 0.8 ha of that area is threatened by soil erosion and landslides. This process is also noticeably visible on the satellite image in the Figure 2. The slope is medium with an average slope of 17% and inclining towards south, east and west. Currently the slope was covered by pasture. The bottom of the slope is afforested with mixed forest (predominantly oak, beech, spruce). However, this afforestation was incomplete. Moreover, deforestation was performed above our study site and the site did not go through reclamation in the form of new planting. Average annual precipitation for this site was 96.08 mm, but during the period May - August 2010 there was 285 mm of precipitation and the slides began to form. In 2011, there was 168 mm of precipitation during May -August. The meteorological data were provided by Slovak Hydrometeorological Institute.

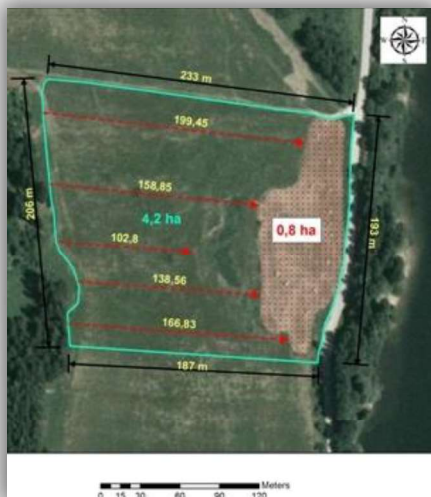
Figure 2: Satellite imagery of the observed area

The resulting estimates from USLE confirmed our assumptions. The highest degree of erosion processes occurred at the bottom of the slope. Figure 2 shows these areas as red dots. Soil loss by erosion ranged from 13 t/ha/year up to 91 t/ha/year. The weighted arithmetic mean was 52 t/ha/y. According to Act No. 220/2004 Coll., the tolerable soil loss on deep soils is 30 tonnes per hectare per year. The soil loss from areas covered by grass was much smaller; it ranged from 0.14 t/ha/year up to 1.82 t/ha/year. To decrease the erosion risk on the site we recommended restoration of the protective forest cover above the boundary of the study area. Another measure would be to return and restore the soil cover at the bottom of the slope. Since the upper part of the soil was flushed away and the subsoil was visible, replenishment of the missing soil would be appropriate. Evenly distributed along the slope, harrowed soil would be the foundation for the infiltration strip along the contour. This would act as a temporary solution, followed by planting woody plants.
